**REPAIR OF THE AL GHAZALIYAH
G-7 SEWAGE LIFT STATION**

UNDER THE COMMANDER'S EMERGENCY RESPONSE PROGRAM

BAGHDAD, IRAQ

**SIGIR PA-07-118
JANUARY 25, 2008**

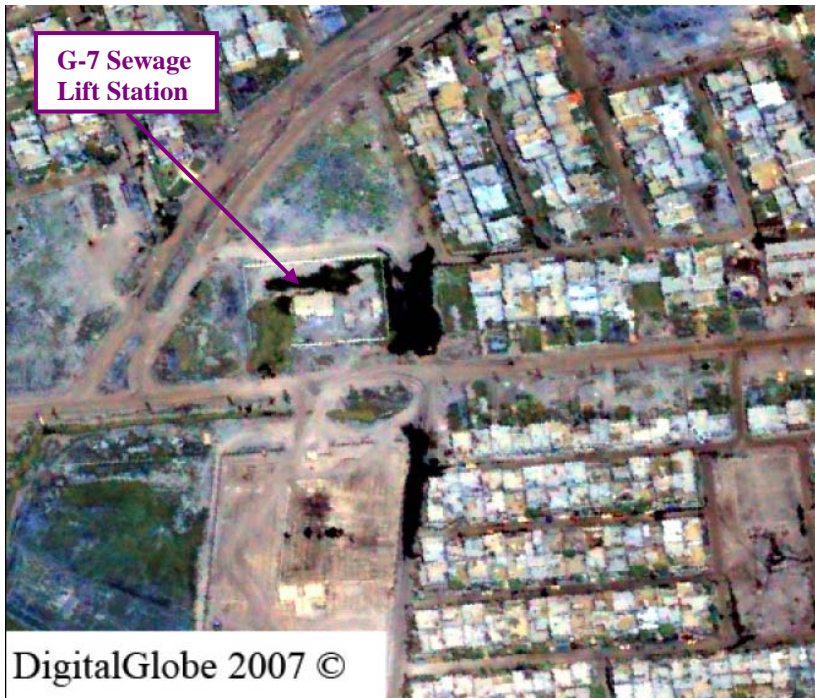
Aerial Image 1. Neighborhood surrounding the G-7 lift station

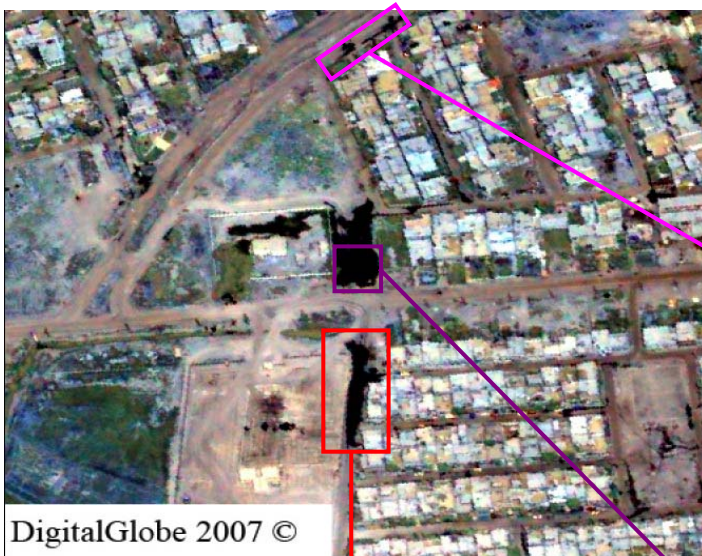
During both site visits, SIGIR identified several streets in the Al Ghazaliyah area with backed-up sewer water (Aerial Image 3 and Site Photos 3-5).

Aerial Image 3. Streets surrounding the G-7 lift station
